Chris Jones, Research Engineer, IIHR Hydroscience and Engineering

Cedar River Geological Overview

Ecosystem Health of the Cedar River Watershed in Iowa and Minnesota

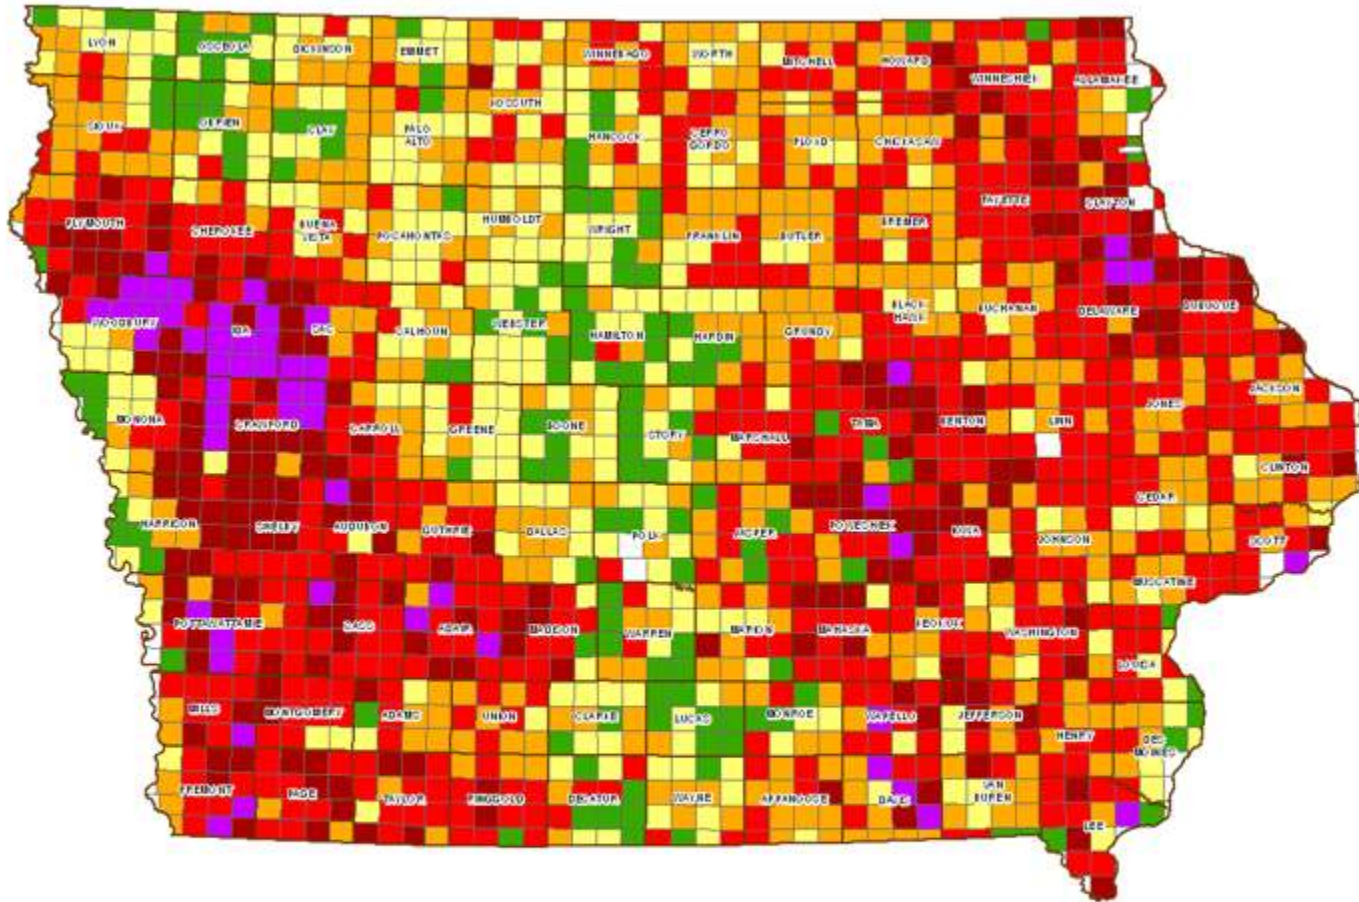
Soil loss is still very high

Average Soil Erosion (tons/acre)

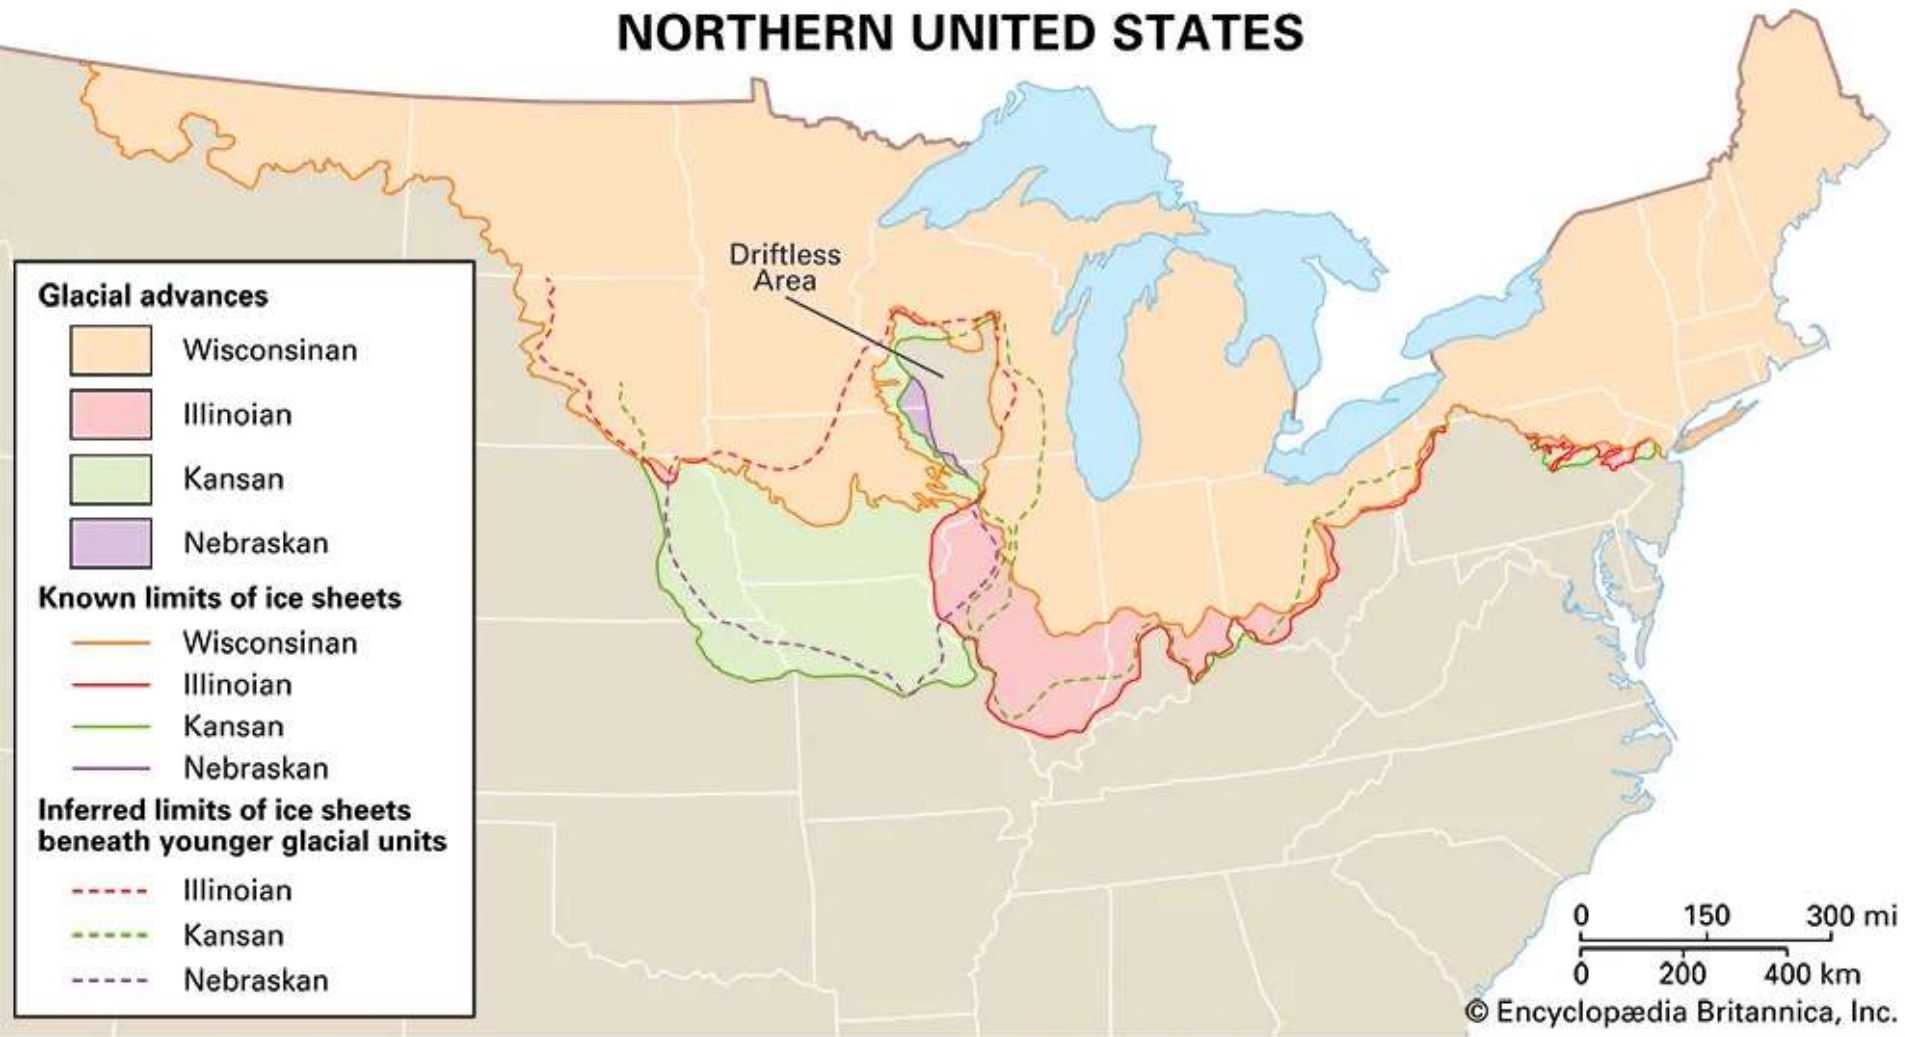
EXTENT OF PLEISTOCENE ICE SHEETS IN THE NORTHERN UNITED STATES

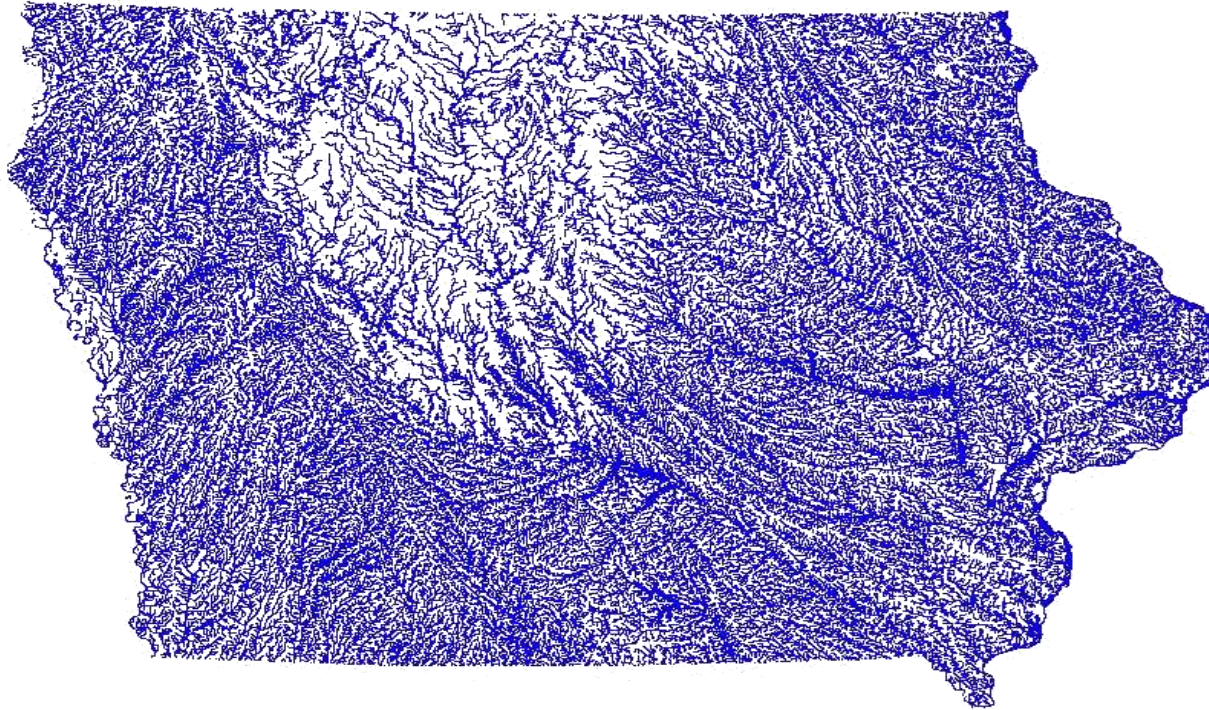
Stream Density low on Des Moines Lobe

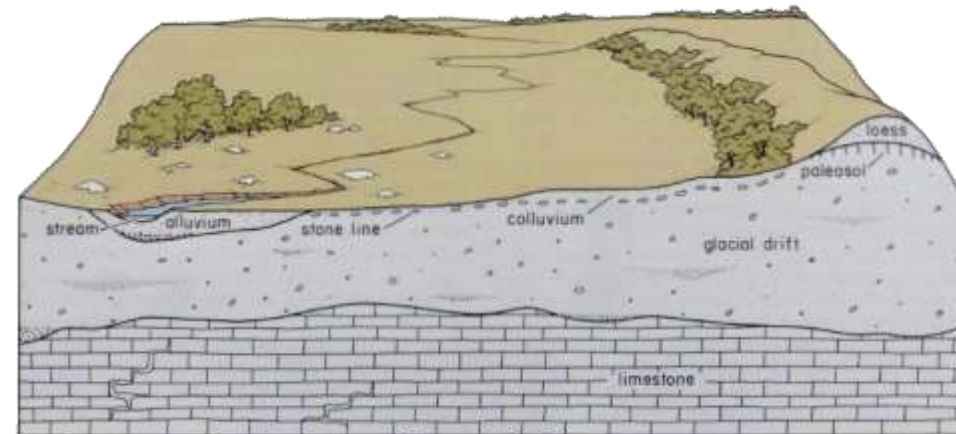
- Thin loess over glacial drift
- Bedrock near the surface
- Approximately level but rolling
- Glacial erratics

Loess and sand, till, bedrock

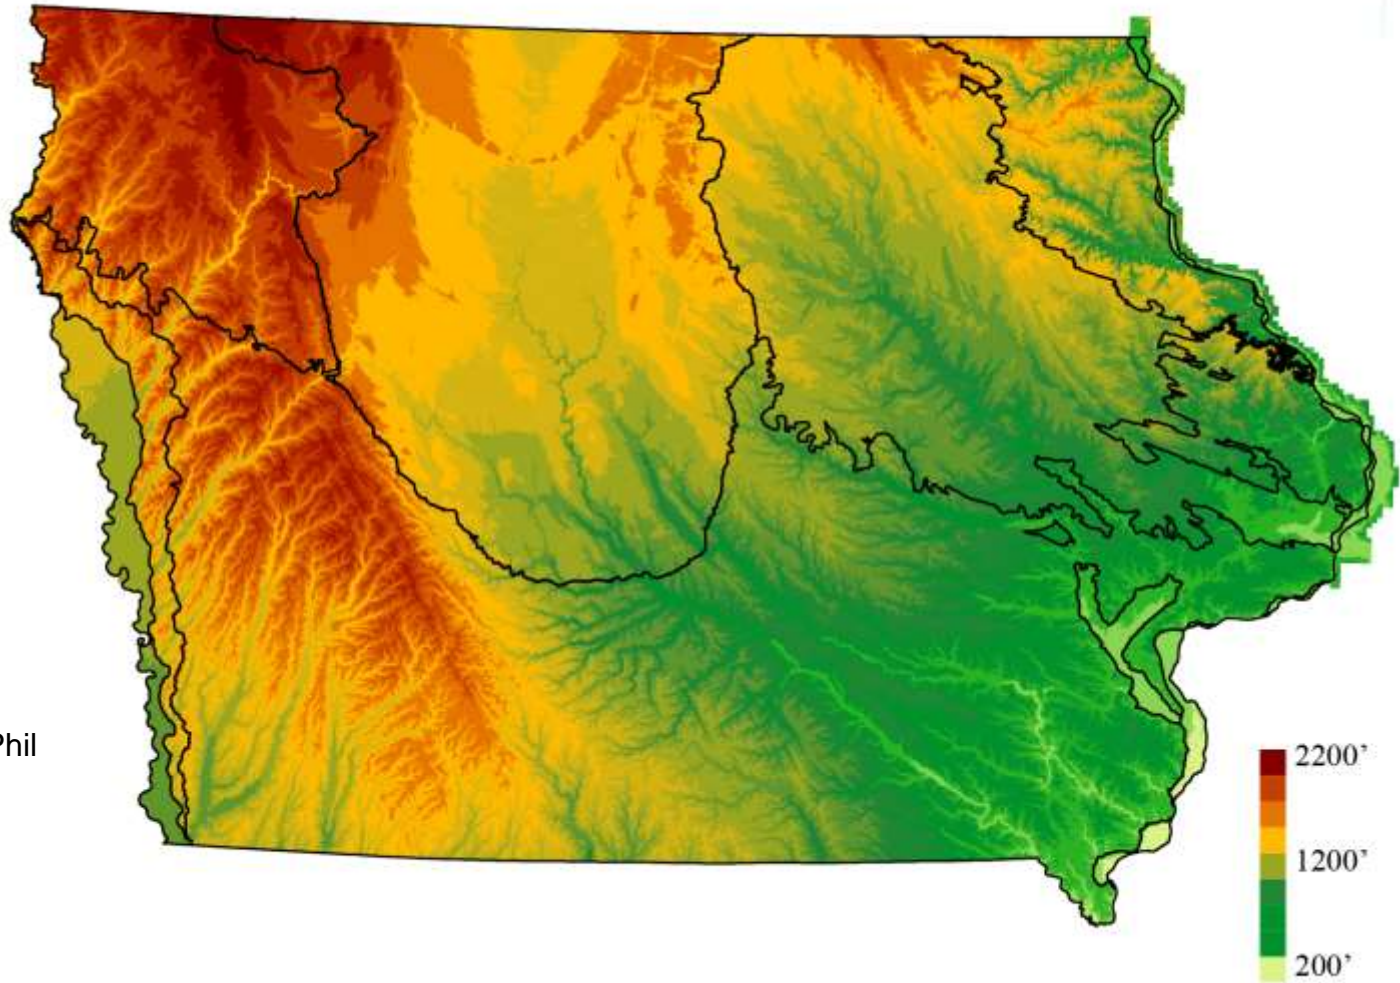
Elevation and landforms

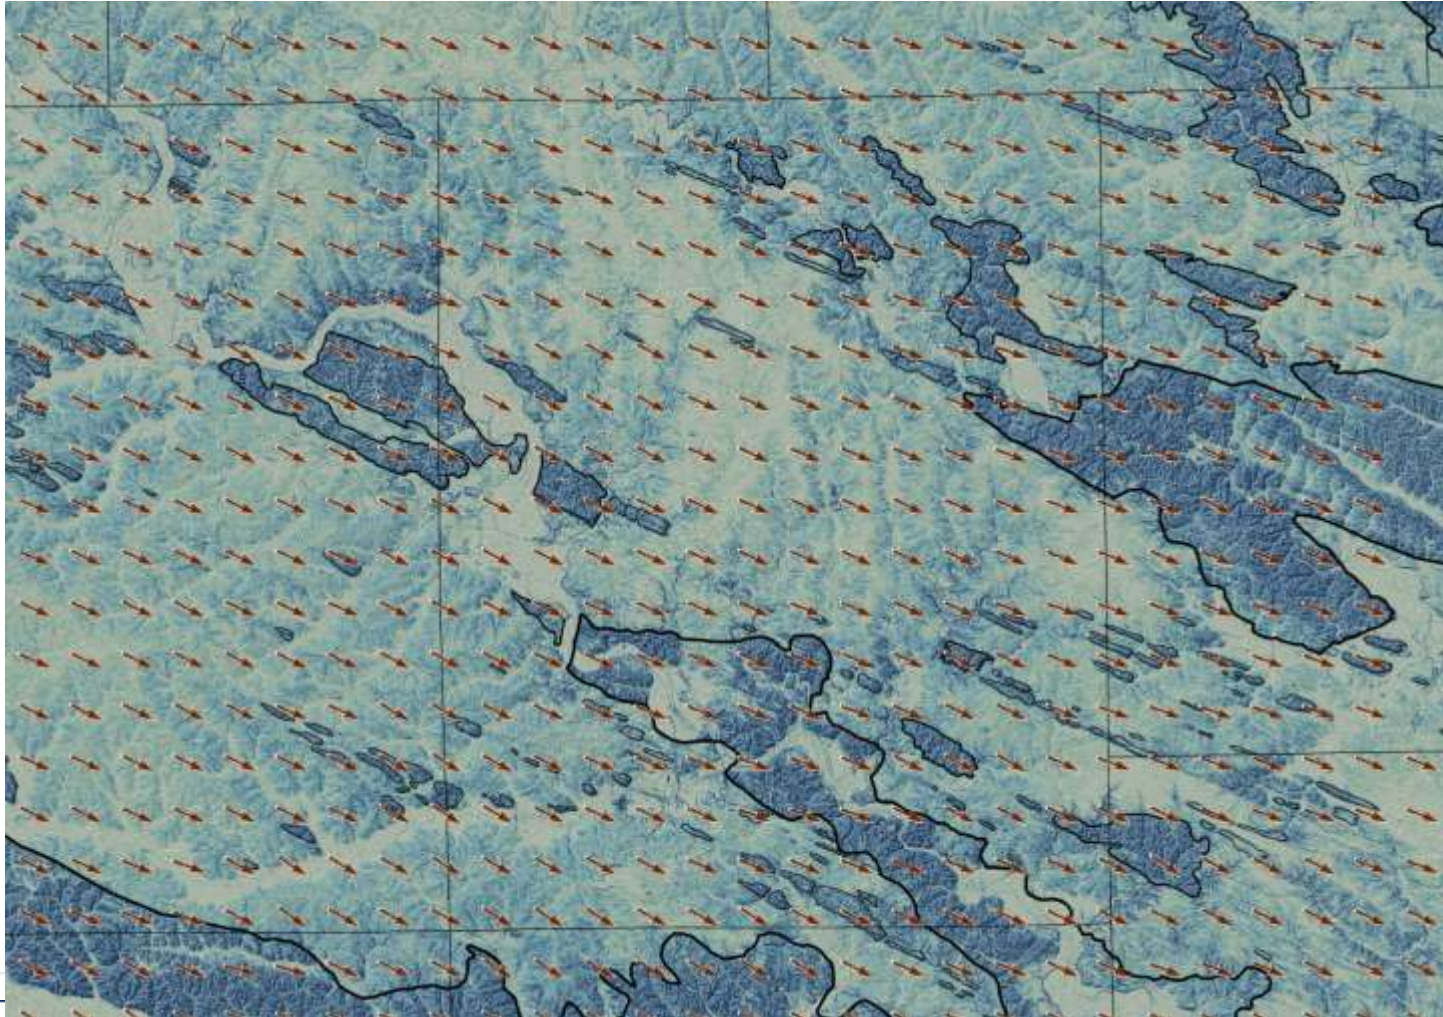
Wind Direction

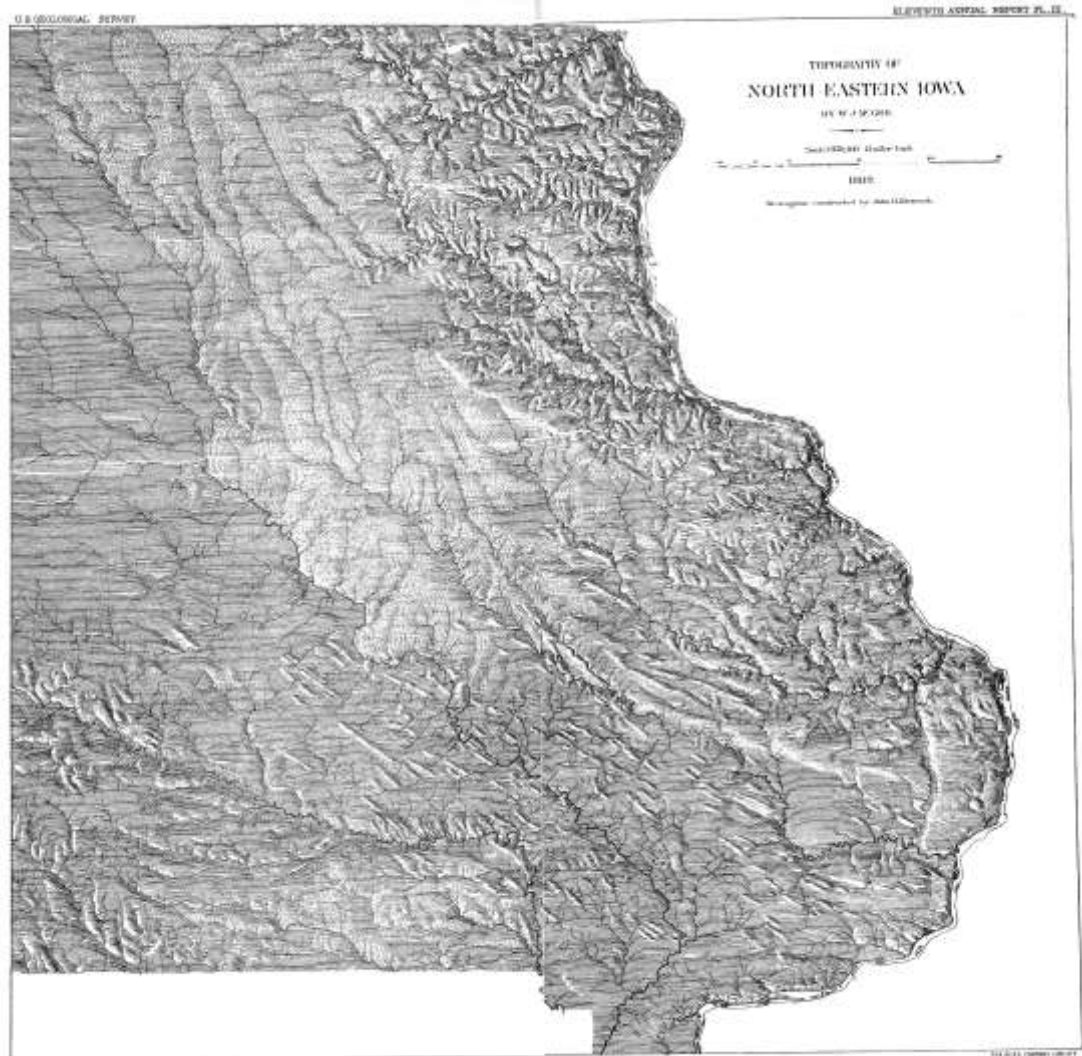
Pahas (McGee 1899)

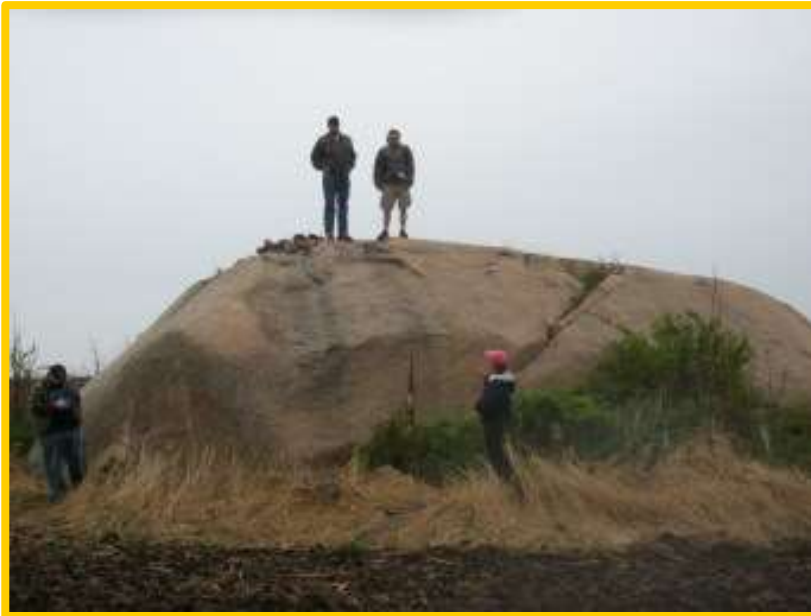
Glacial Erratics

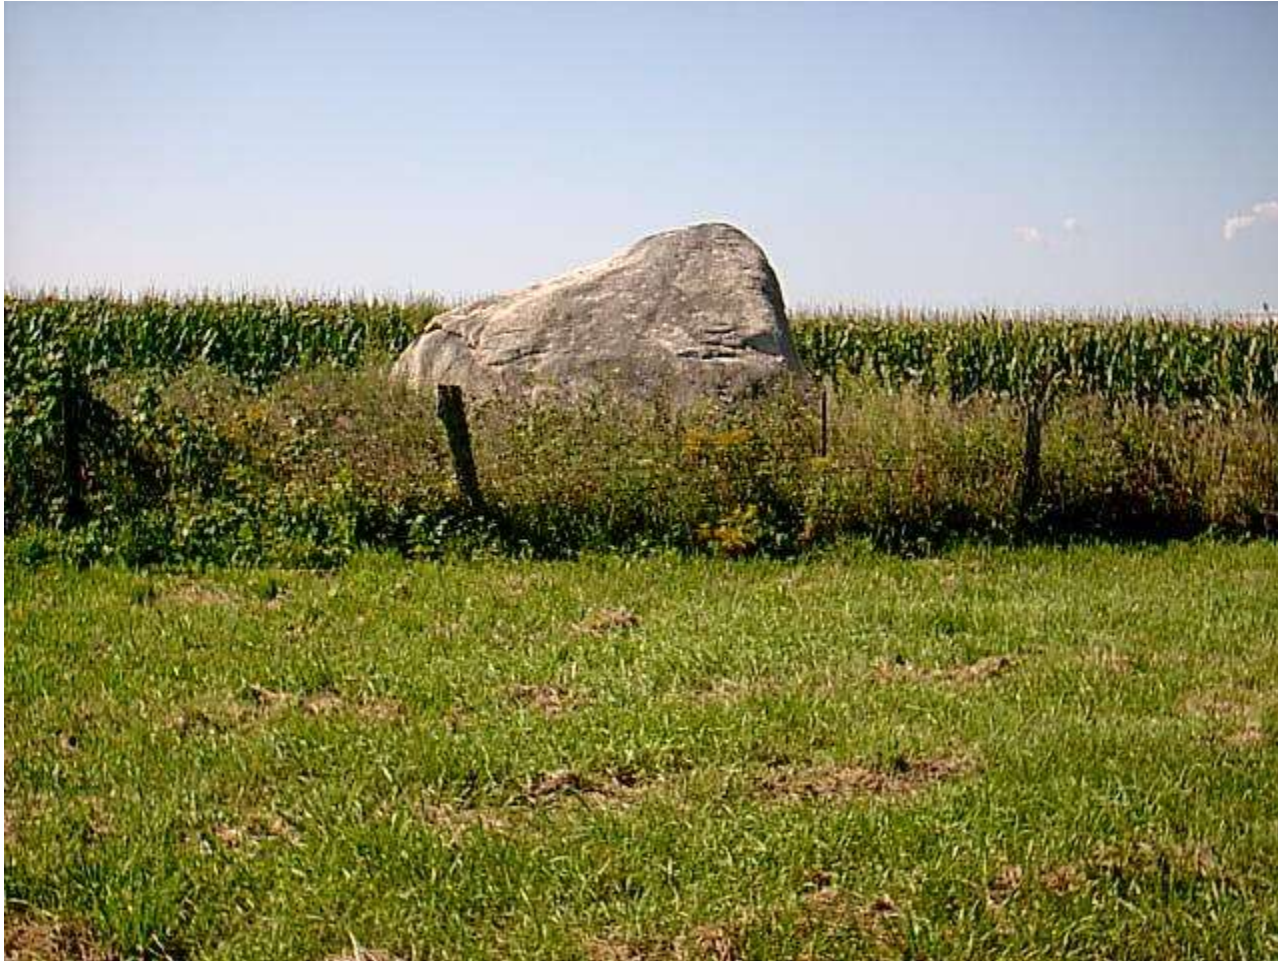
Glacial Erratics

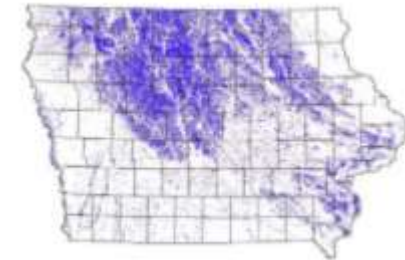
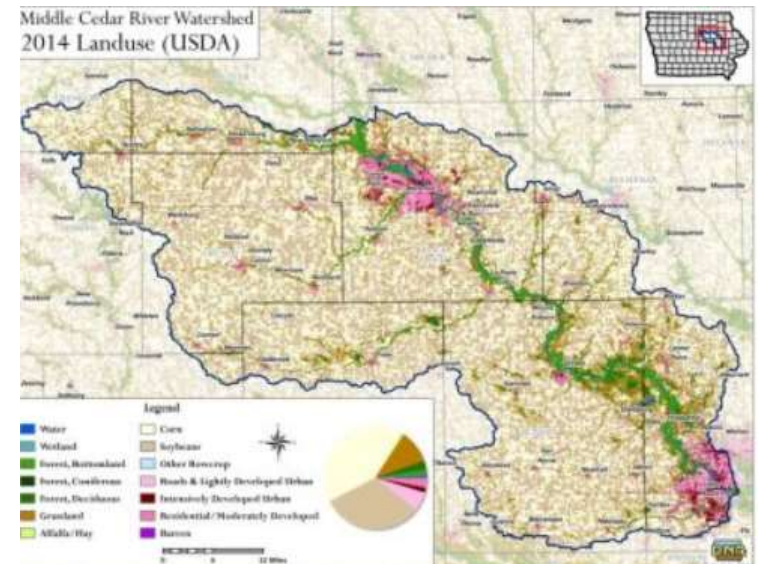
2 million miles of tile in Iowa

1200 miles new tile/year!
